METALS HANDBOOK

VOL. 9
FRACTOGRAPHY AND ATLAS OF FRACTOGRAPHY

8th EDITION

Fractography and Atlas of Fractographs

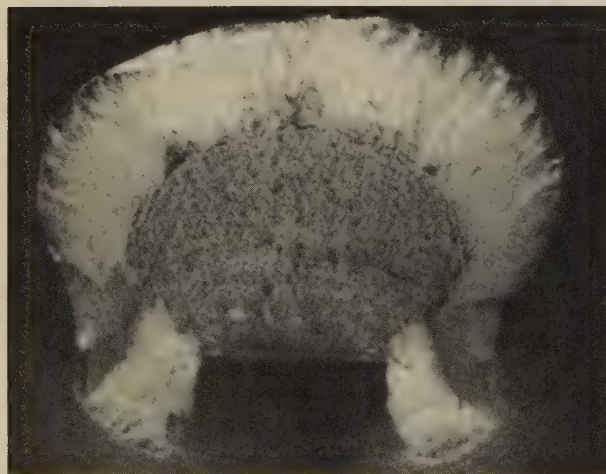
4443

Light fractograph

Cup-and-cone fracture in an unnotched specimen of 13-8 PH stainless steel (tensile strength, 1634 MPa, or 237 ksi) broken in tension overload. Central area, where fracture began, appears to be uniformly and finely fibrous. See also 4444, at right.

9×

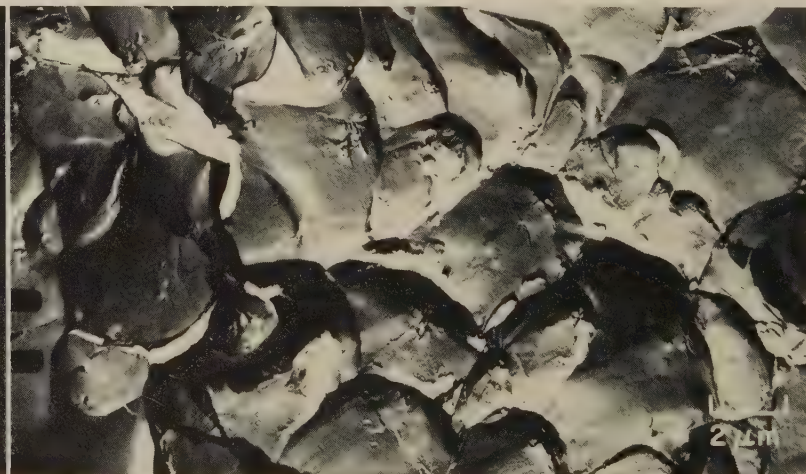
TEM fractograph (p-c replica)

5000×

A TEM view of the central area in the surface of the cup-and-cone fracture in fractograph 4443 (at left), showing dimples that are approximately equiaxed. There appear to be indications of inclusions at the tips of most of the dimples. A few of the dimples are slightly elongated, which suggests proximity to the shear lip.

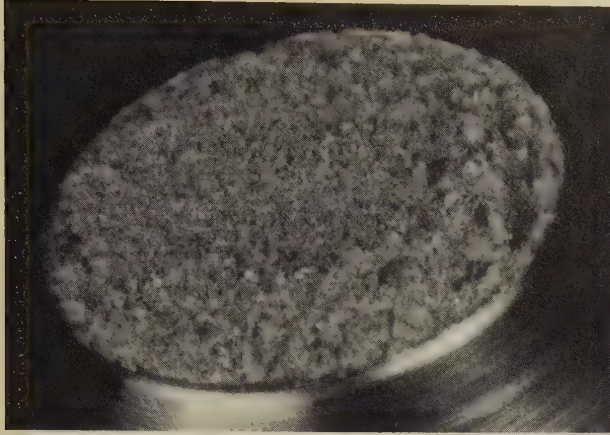
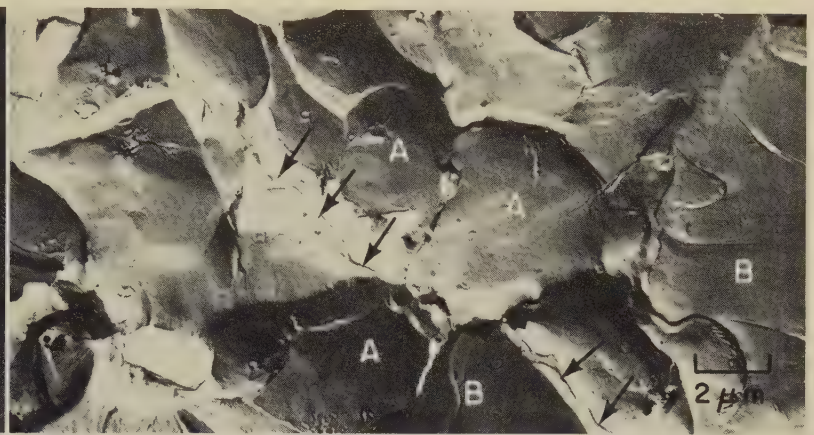
4445, 4446

Light fractograph

9× TEM fractograph (p-c replica)

Fractograph 4445 (left) shows a fracture in a notched specimen of 13-8 PH stainless steel (same unnotched tensile strength as in 4443), broken in tension overload. Notched tensile strength was 2423.5 MPa (351.5 ksi). The fracture surface is fibrous. Specific sites of fracture origin in the notch root are not visible. Fractograph 4446 (right) is a TEM view of the fracture surface in 4445, showing large dimples (as at A's). The surfaces of the dimples are remarkably smooth, in some instances suggesting stretched areas (B's). A few minor secondary cracks are evident (at arrows). The only inclusions visible here are tiny.

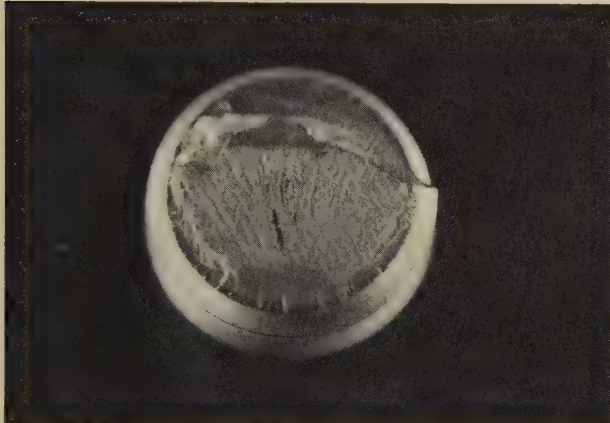
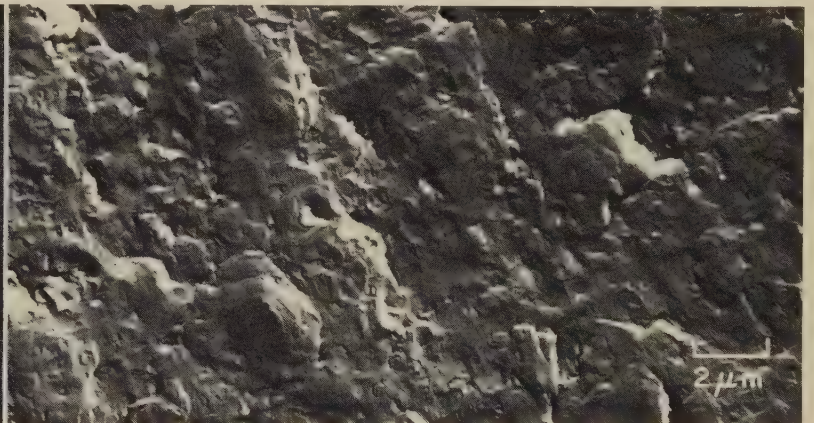
4447, 4448

Light fractograph

6× TEM fractograph (p-c replica)

At left (fractograph 4447) is a low-cycle fatigue fracture in a threaded bolt of 13-8 PH stainless steel (same tensile strength as 4443) that was loaded in tension-tension ($R = 0.1$) under a maximum stress of 60% of the tensile strength. Fracture occurred at 16,000 cycles. Several crack nuclei are visible along the thread root. Fractograph 4448 (right) is a TEM view within the fatigue crescent at the bottom of the fracture surface in 4447. This view displays very little evidence of identifiable fatigue striations; no dimples are apparent. Instead, the surface bears some resemblance to one resulting from cleavage.

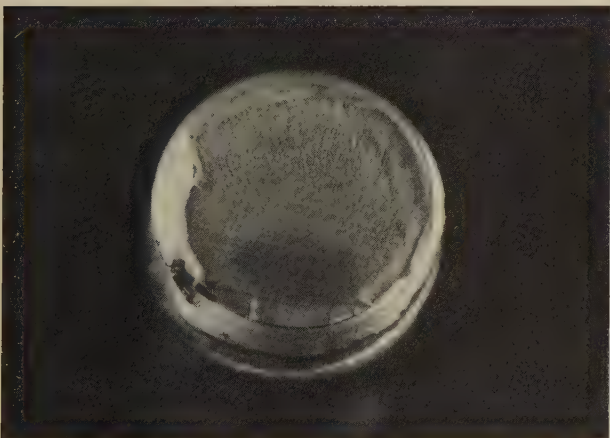
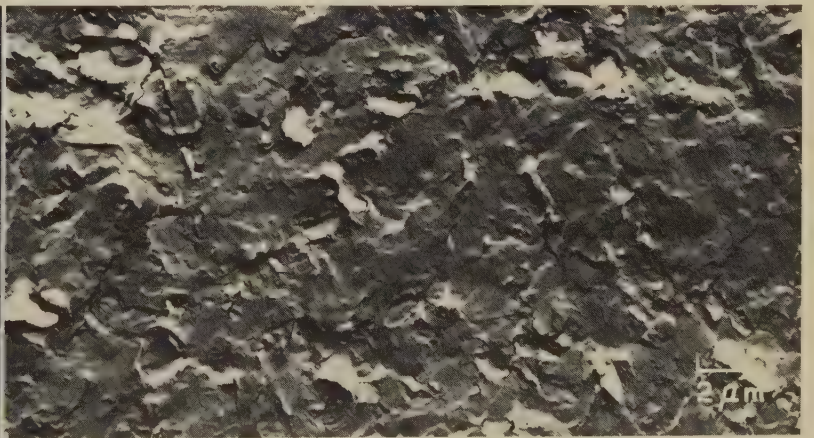
Light fractograph

6× TEM fractograph (p-c replica)

Fractograph 4449 (left) shows a high-cycle fatigue fracture in a threaded bolt of 13-8 PH stainless steel (same tensile strength as 4443) that was loaded in tension-tension ($R = 0.1$) under a maximum stress of 30% of tensile strength. Fracture occurred at 959,000 cycles. Several crack nuclei are visible in the thread root. Fractograph 4450 (right) is a TEM view of a region well within the fatigue crescent in 4449. This view shows no fatigue striations except for those in one or two tiny wrinkled areas near the top. The surface has angular characteristics suggesting a crystallographic influence on fracture path.

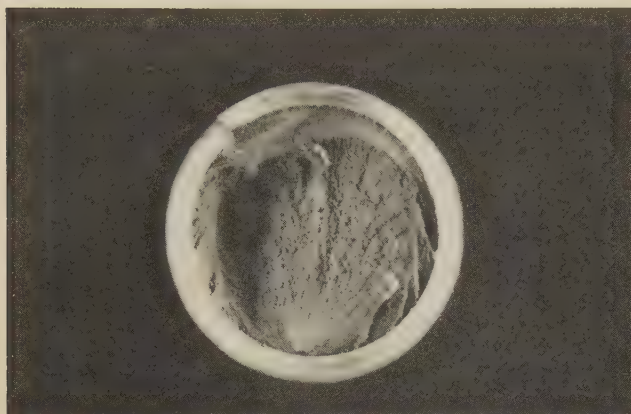
Light fractograph

6×

4451 Surface of a fracture in a hydrogen-embrittled, threaded tensile specimen of 13-8 PH stainless steel (tensile strength, 1634 MPa or 237 ksi) that was electrolytically charged with hydrogen and broken without having been baked. Fracture occurred around the thread roots before the specimen was fully stressed to 75% of tensile strength. A radial fibrous surface. See 4452.

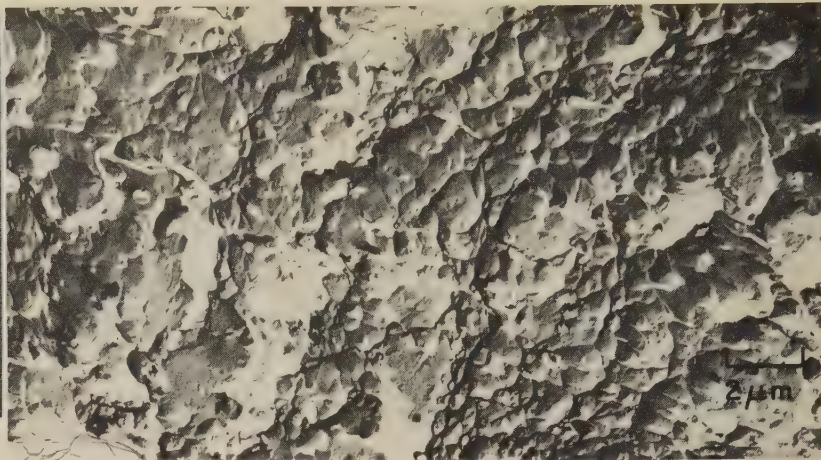
TEM fractograph (p-c replica)

5000×

4452 TEM replica of an area in the radial fibrous region of the fracture surface in 4451 (left), showing what apparently are separated-grain surfaces mostly covered with small dimples. In addition, there are larger dimples that may have resulted from microvoid coalescence during local transgranular fracture. A few small facets suggest cleavage.

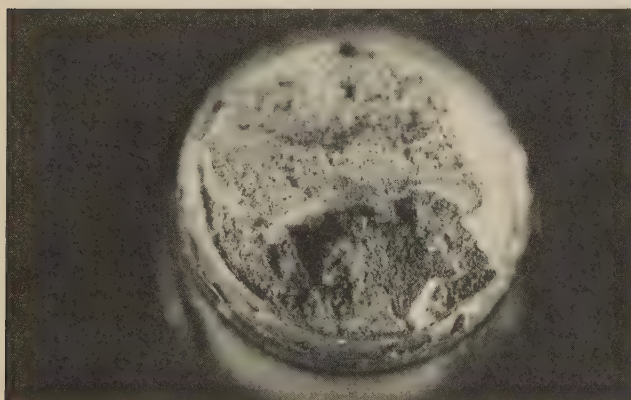
Light fractograph

6×

4453 Surface of a fracture that resulted from stress-corrosion cracking in a bolt of 13-8 PH stainless steel (same tensile strength as in 4451) that was stressed to 75% of tensile strength while immersed in a 3.5% solution of NaCl in water. The region of stress-corrosion cracking is at bottom. A coating of corrosion products is evident. See fractograph 4454 (right).

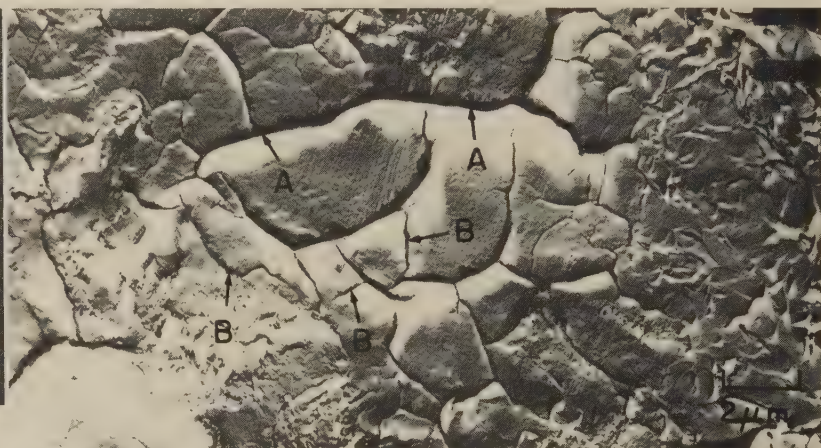
TEM fractograph (p-c replica)

5000×

4454 TEM replica of an area in the region of stress-corrosion cracking in the fracture surface in 4453 (left), showing a complicated network of intergranular (arrows A) and transgranular (arrows B) secondary cracks. Some facets are relatively clean; others (at right) show a layer of a corrosion product (probably a hydroxide), which is cracked also.

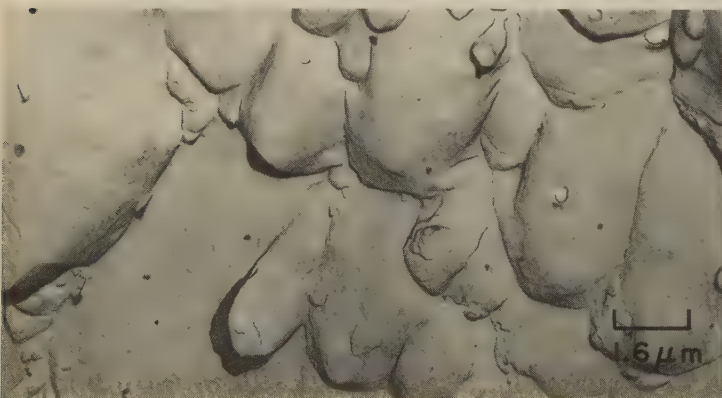
TEM fractograph (p-c replica)

6450×

4455 Surface of a tension-overload fracture in an unnotched specimen of 17-4 PH stainless steel bar aged at 482 C (900 F) to a tensile strength of 1241 to 1379 MPa (180 to 200 ksi). This TEM replica shows the center of a cup-and-cone fracture surface exhibiting the expected elongated dimples. See 4456.

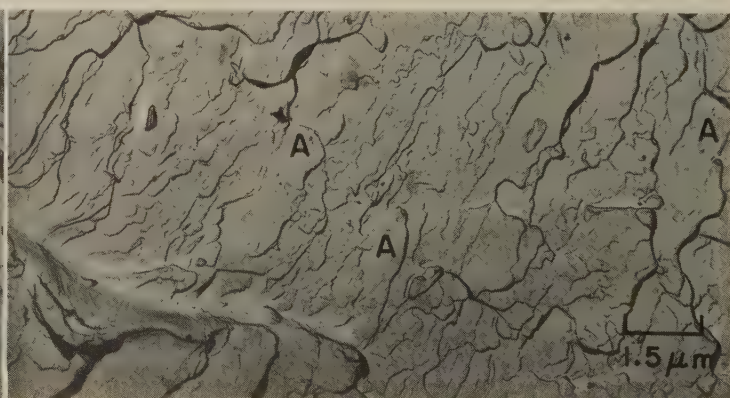
TEM fractograph (p-c replica)

6500×

4456 Surface of a tension-overload fracture in a notched specimen of 17-4 PH stainless steel bar aged same as that in 4455. There appear to be very sharp cleavage steps in this region. Features in scattered areas (as at A's) resemble very flat dimples, but such dimples are rarely found on cleavage surfaces.

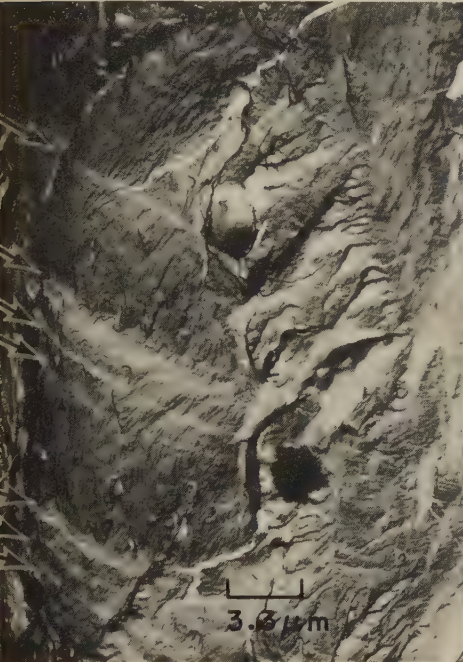
TEM fractograph (p-c replica)

3000×

4458 TEM view of the fracture surface in 4457, showing features typical of those in areas 3 to 8. Arrows at left point out fatigue striations, and cleavage marks are visible at right.

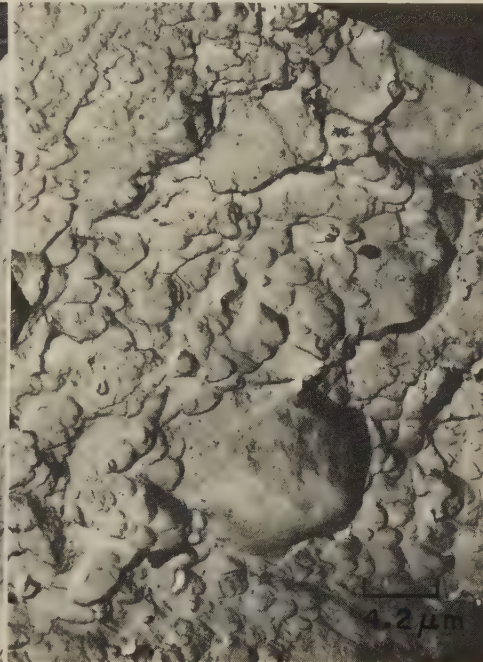
TEM fractograph (p-c replica)

2400×

4459 TEM view of the fracture surface in 4457, showing dimples, typical of those in areas 1 and 2, formed by shear overload during final fracture. Fracture occurred at the vibration node in the web.

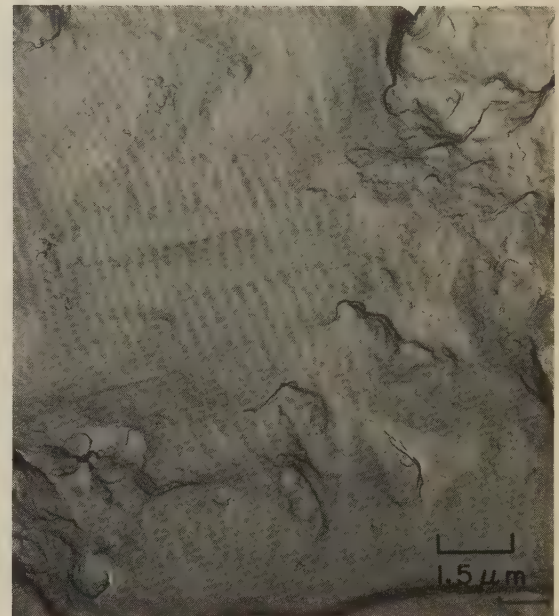
TEM fractograph (p-c replica)

6500×

4463 TEM replica of an area at A in 4462, showing a smooth surface with regular fatigue striations and with scattered features that resemble partly developed dimples.

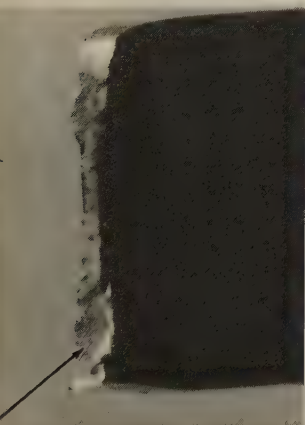
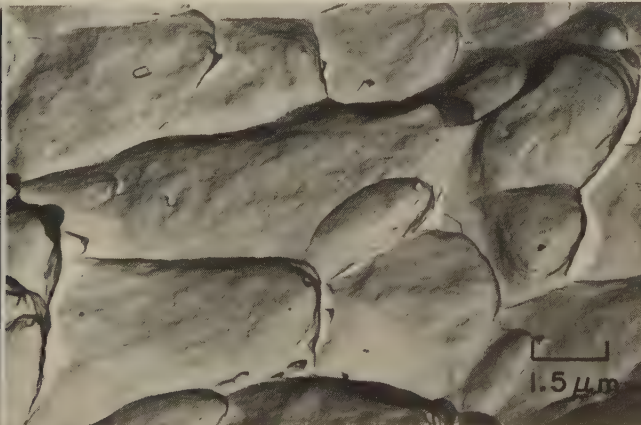
4460, 4461

Light fractograph

4×

Fractograph 4460 (left) shows the surface of a tension-overload fracture in an unnotched specimen of type 302 stainless steel tested at room temperature. Tensile strength was 627 MPa (91 ksi). The fracture occurred entirely by shear, with appreciable necking. Fractograph 4461 (right) is a TEM replica of an area at the arrow in 4460, showing the elongated dimples expected in a shear-fracture surface. The dimples are large and well formed.

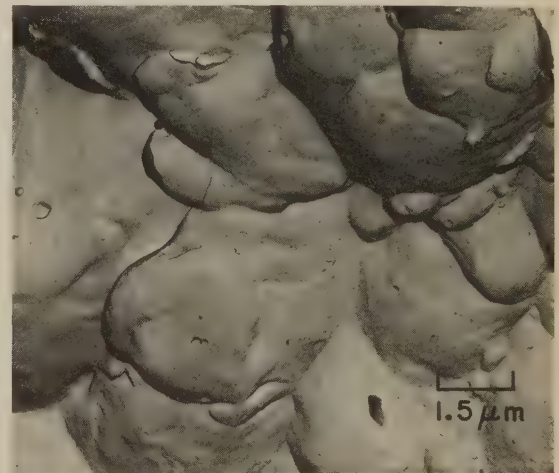
TEM fractograph (p-c replica)

6500×

4464 TEM replica of an area at B in 4462, which is within the region of final, fast fracture. Here, dimples can be seen that are somewhat elongated, which conforms to the shear mechanism of fracture observed in this region.

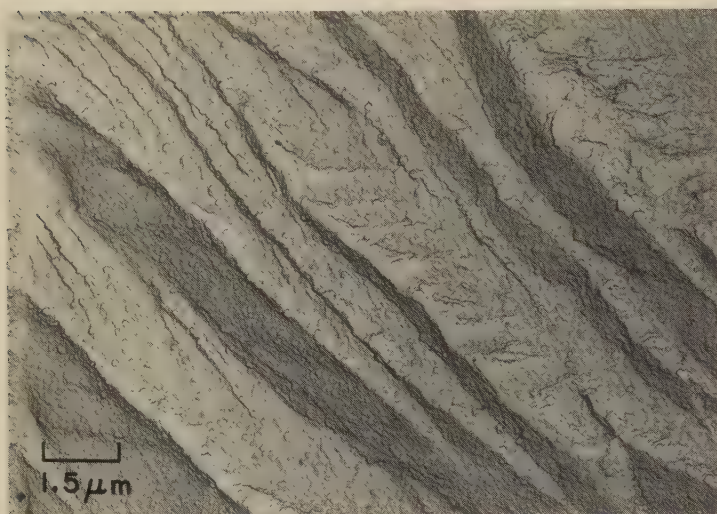
TEM fractograph (p-c replica)

6500×

4465 TEM replica of an area near A, close to the notch, in the fracture in 4467 (below), showing definite cleavage steps and essentially no evidence of fatigue striations. A thin oxide film is present. See also fractograph 4466 (right).

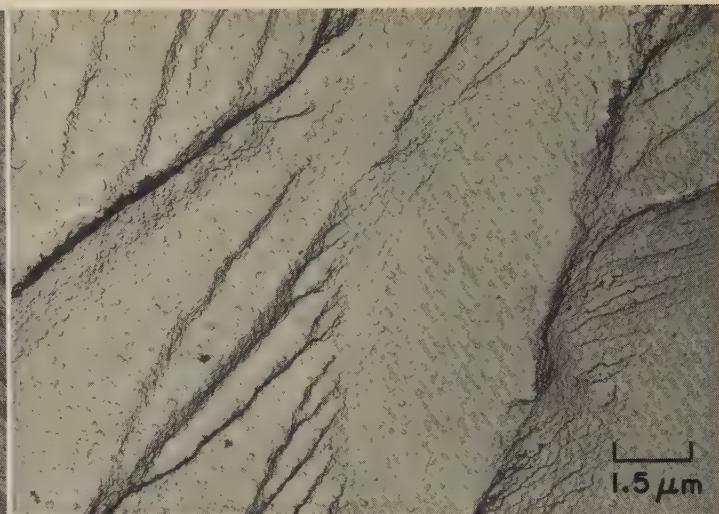
TEM fractograph (p-c replica)

6500×

4466 TEM replica of another area near A in 4467, also showing evidence of cleavage steps. The fine marks at right, which are essentially parallel to the cleavage direction, probably are not fatigue striations. See also 4468 to 4475.

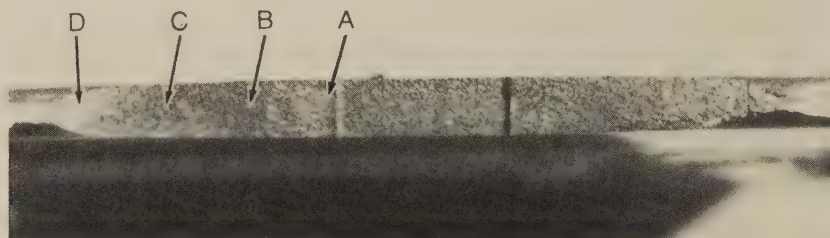
Light fractograph

5×

4467 Surface of a high-cycle fatigue fracture in a notched specimen of type 302 stainless steel sheet subjected at 427 C (800 F) to tensile stress cycled from 24.8 to 124 MPa (3.6 to 18 ksi) at 1000 cycles per minute. Fracture occurred after 1,625,450 cycles. The notch in the specimen was a center hole 0.01 in. in radius and 0.20 in. wide. Fatigue area became purple; fast-fracture area became straw colored, with shear and necking. See 4465 and 4466 (above), and 4468 to 4475 (below and on next page), for views at A, B, C and D.

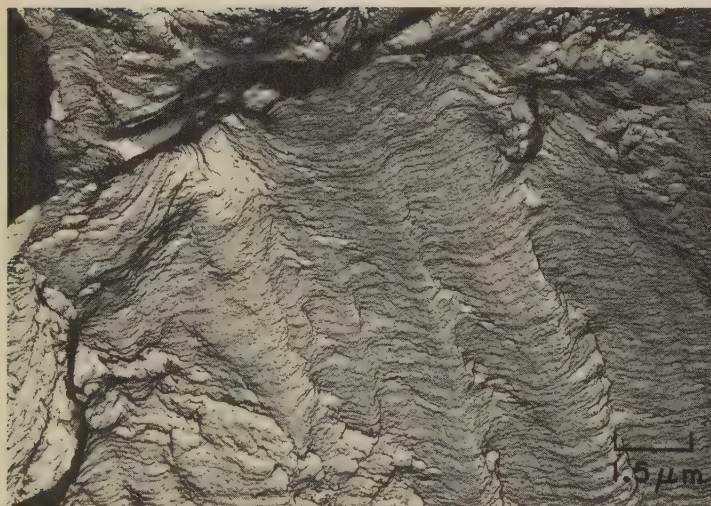
TEM fractograph (p-c replica)

6500×

4468 TEM replica of a third area near A in the fracture surface shown in 4467. Here, fatigue striations are present in rather narrow and somewhat irregular patches. Some evidence of surface oxidation can be seen.

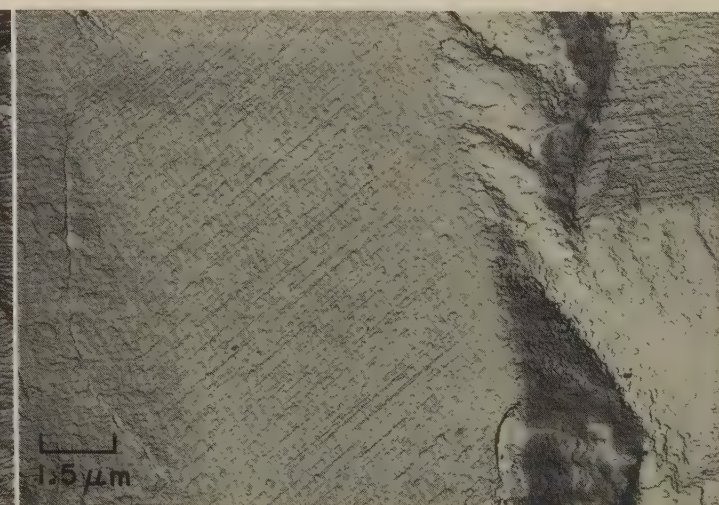
4469 TEM replica of a fourth area near A in the fracture surface in 4467, showing flat facets quite suggestive of intergranular cleavage. The parallel marks may not be fatigue striations but rather features associated with the oxide film.

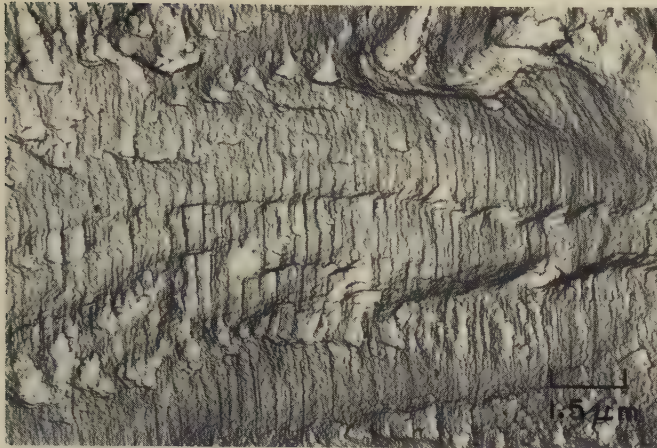
4470 TEM replica of a fifth area near A in the fracture surface in 4467 (facing page). This area is characterized by narrow patches of extremely sharp and distinct fatigue striations. Again, the oxide film is apparent.

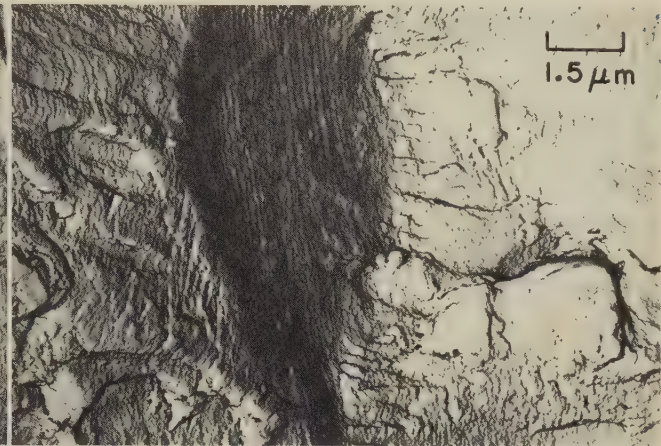
4471 TEM replica of a sixth area near A in the fracture surface in 4467, showing distinct fatigue striations. The markings to the right of the dark region are believed to be cleavage steps, not fatigue striations.

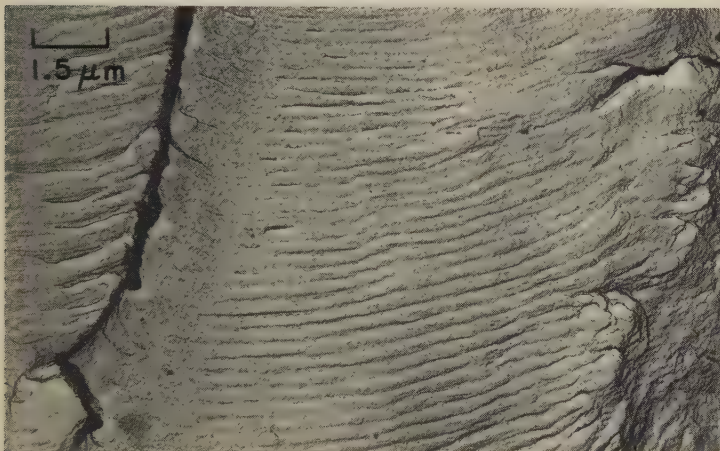
4472 TEM replica of an area at B, approximately 0.09 in. from the notch, in the fracture surface shown in fractograph 4467. The heavy, black mark at left is the result of a sharp difference in level at the junction of two crack fronts. The fatigue striations here are regular and well developed.

4473 TEM replica of an area at C, about 0.175 in. from the notch, in 4467. Note that the fatigue striations here are more widely spaced than those in 4472, which indicates that the effective stress increased as the crack penetrated into the specimen. Partly formed dimples are visible above and right of center.

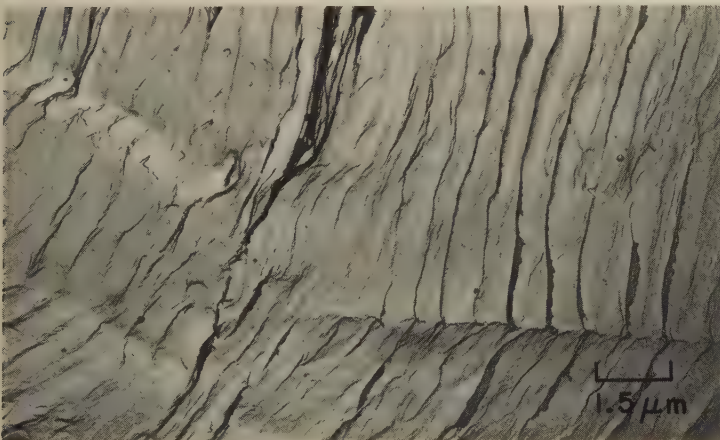
4474 TEM replica of another area near C in 4467, showing a further increase in fatigue-striation spacing. A junction of two crack fronts is visible at lower right. Secondary cracks appear to have formed at some striations.

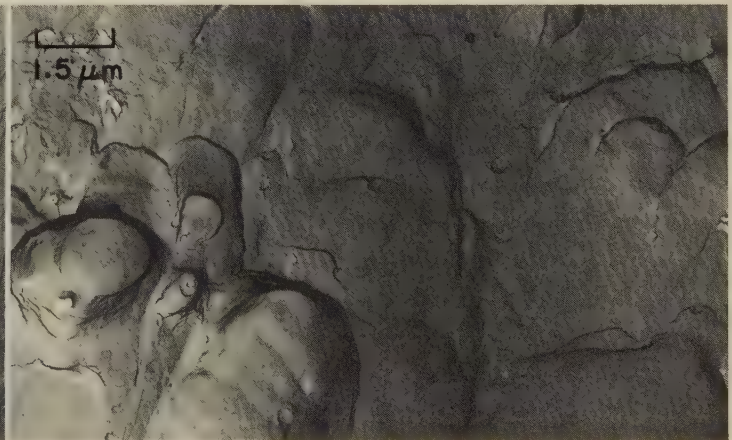
4475 TEM replica of an area at D, in the region of final, fast fracture and about 0.46 in. from the notch, in 4467. The elongated dimples confirm that final fracture was by shear. Fatigue striations ceased to form when this final stage of fracture began.

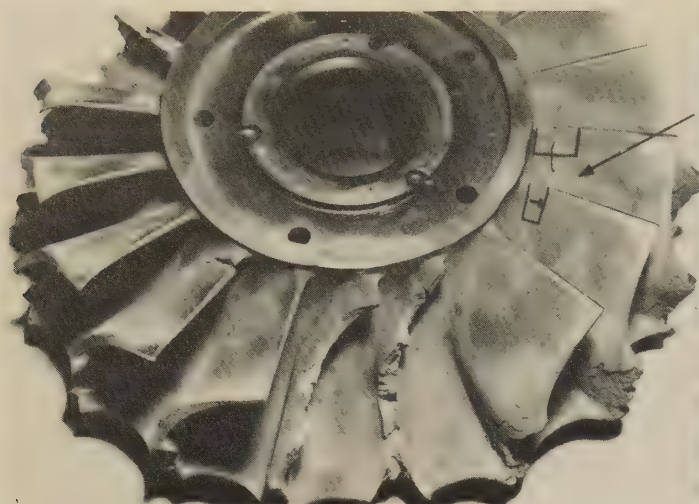
4476 A gas-producer turbine rotor cast of alloy 713LC that fractured after 440 hr of service, as the result of hot corrosion fatigue. Fracture was abrupt, with three blades being thrown off. See 4478 (below) for a view of the area near the arrow. See also fractographs 4477 and 4479.

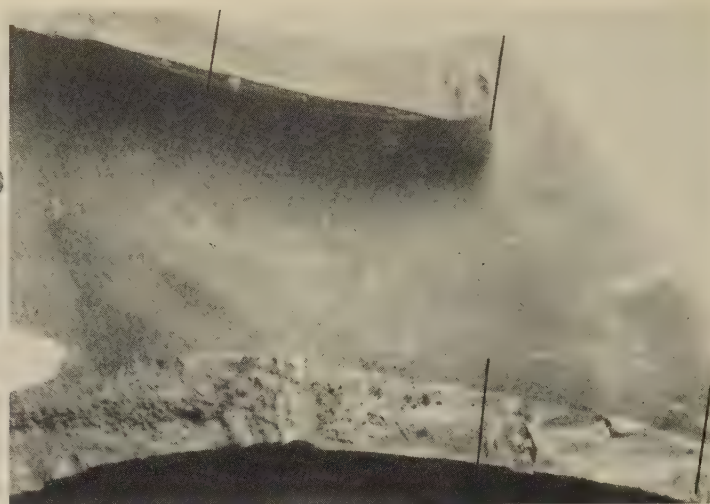
4477 Fracture surfaces of the two broken turbine-rotor blades at the bottom in photograph 4476. Fatigue beach marks are faintly visible at right on the fracture surface of the lower blade. The region between the parallel black lines on each blade was examined by electron microscopy.

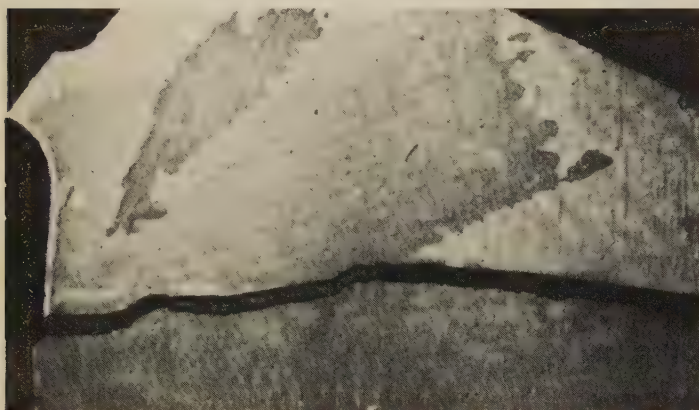
4478 A macroetched view of a cracked turbine-rotor blade near the arrow in photograph 4476 (above), displaying large columnar grains and a crack that initiated at the trailing edge (at left in this view) of the blade. This crack appears to have followed an intergranular path.

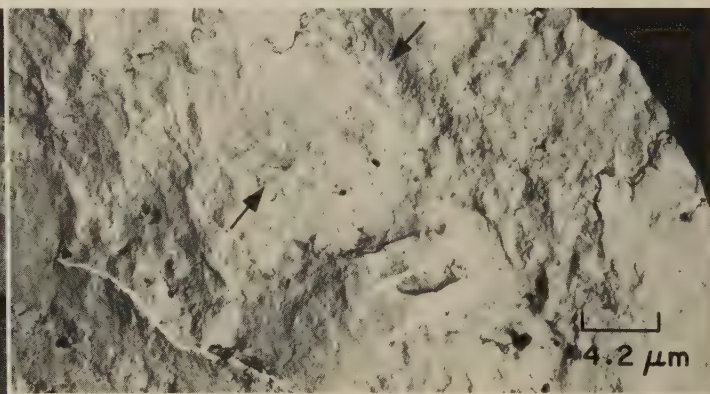
4479 A TEM view of a fracture surface of one of the turbine-rotor blades in fractograph 4477 (above). This view is typical of all the areas examined. A patch of fatigue striations is faintly visible at center between arrows. The fatigue crack is believed to have been initiated by hot corrosion, which was shown, by sectioning of blades, to exist at concentrations of lead.

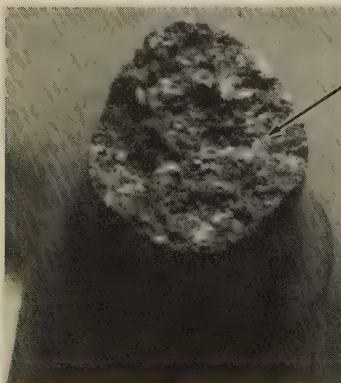
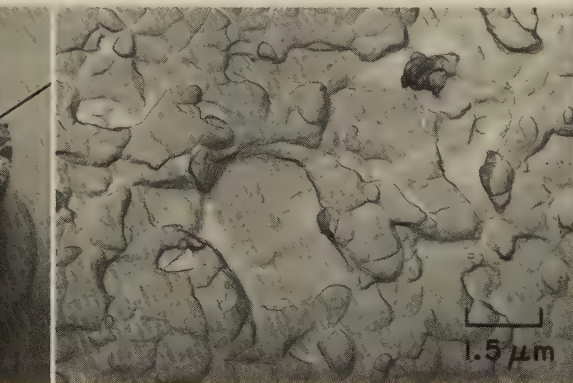
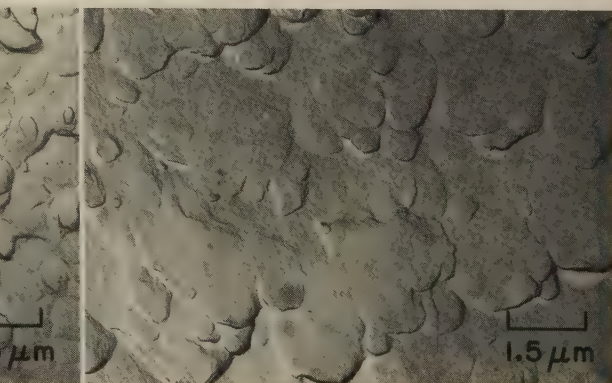
4480, 4481, 4482

Fractograph 4480 (left) shows a room-temperature tension-overload fracture in an unnotched specimen of cast alloy 713C annealed at 1149 C (2100 F); tensile strength was 827 MPa (120 ksi). Fractograph 4481 (center) is a TEM view of an area near the arrow in the extremely jagged fracture surface in 4480, showing equiaxed dimples; these were produced by microvoid coalescence during the tension overload. Fractograph 4482 (right) is a TEM view of a second area near the arrow in 4480. This area displays rather flat shear dimples, which are appreciably larger than the equiaxed dimples in 4481.

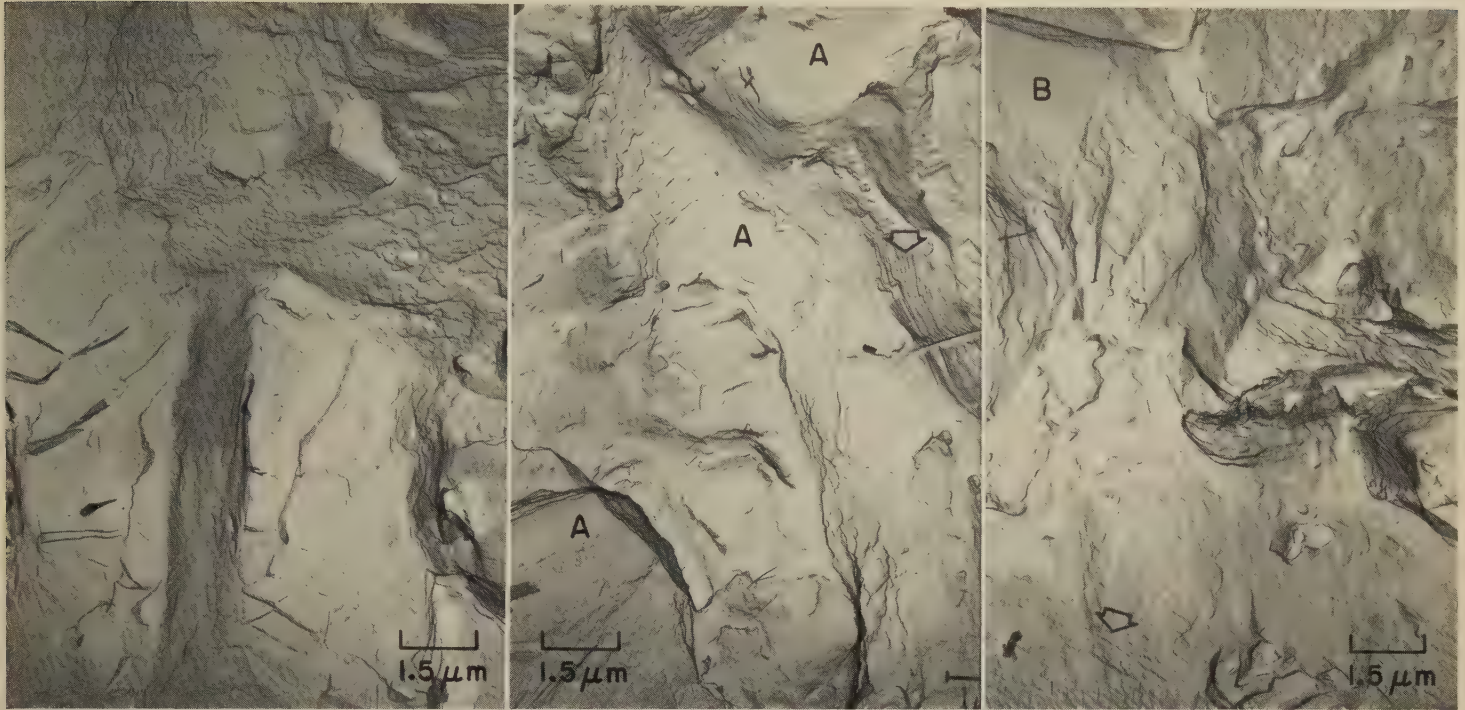
TEM fractograph (p-c replica)
4483, 4484, 4485

TEM views of three more areas near the arrow in fractograph 4480 (facing page). Fractograph 4483 (left) is of an area with features that suggest local rupture by a combination of intergranular separation and microvoid coalescence. There are a number of hairline indications on the separated-grain facets. Fractograph 4484 (center) is of an area in which several very smooth regions (as at A's) show localized stretching. The arrow, at right, indicates a group of slip planes. Fractograph 4485 (right) shows an area that contains a number of examples of slip, one of which is marked by the arrow, at lower left. Stretching is evident in the upper left corner of this view (at B).

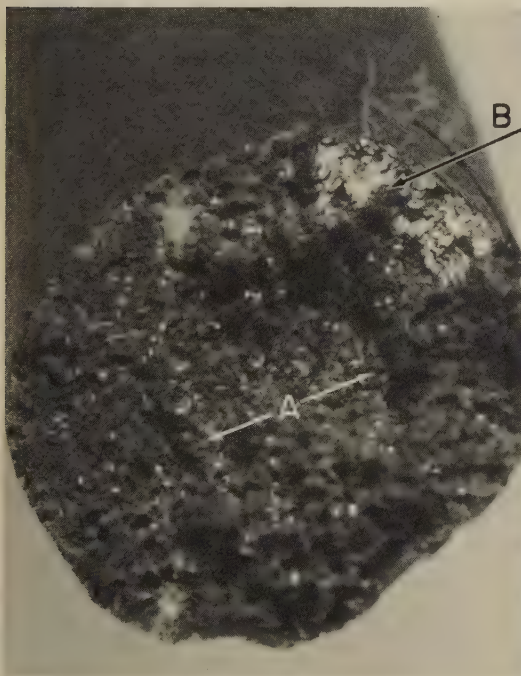
4486 Surface of a stress-rupture fracture in a cast specimen of alloy 713C annealed at 1149 C (2100 F) to a tensile strength of 827 MPa (120 ksi). The test was at 816 C (1500 F) in air, with stress of 276 MPa (40 ksi); fracture occurred at 645 hr. The fracture was jagged and showed secondary cracks (arrows at A). See 4487 and 4488 for views of areas at arrow B.

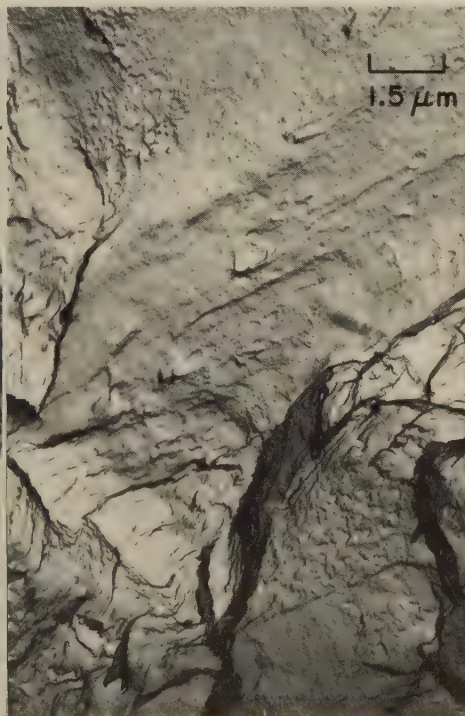
4487 A TEM view of an area in the shiny region at arrow B in 4486. Surface here suggests intergranular separation and carries a layer of oxidation products. There are a few suggestions of dimples on separated-grain facets.

4488 A TEM view of another area at arrow B in 4486. The intergranular nature of the fracture is more pronounced here. As in 4487, the surface is coated with a layer of oxide, which contributes some of the marks visible.

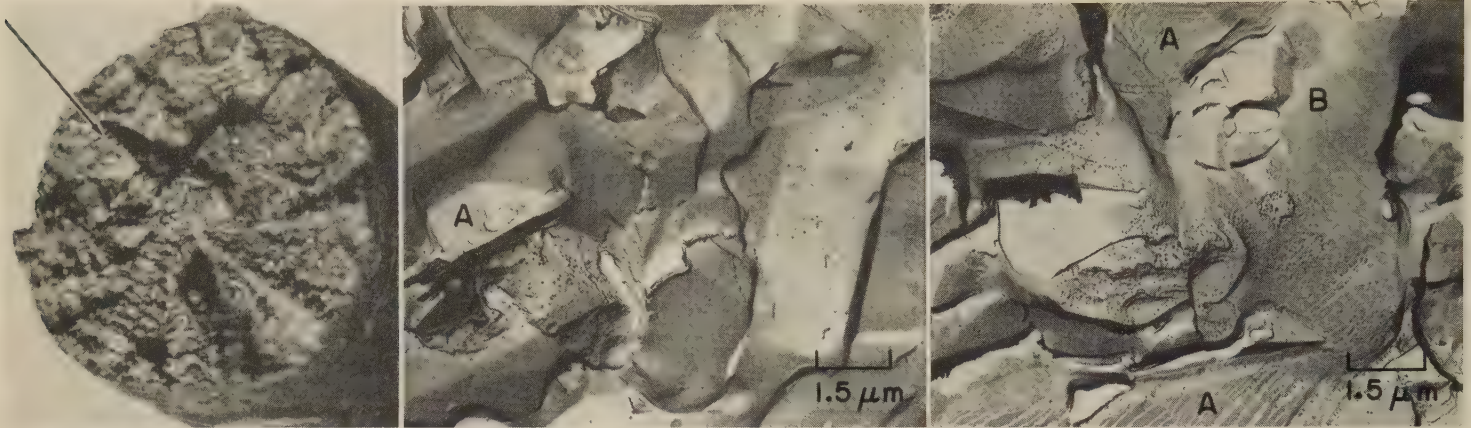
4489, 4490, 4491

Fractograph 4489 (left) shows the surface of a dendritic stress-rupture fracture in a cast specimen of IN-100 nickel-base alloy that was annealed at 1177 C (2150 F) and loaded at 982 C (1800 F) to a tensile stress of 97 MPa (14 ksi). The specimen broke after 49 hr of testing. Fractograph 4490 (center) is a TEM replica of an area at the arrow in 4489, showing some evidence of intergranular separation and some facets of what appear to be cleaved particles (as at A) of intermetallic compounds. Fractograph 4491 (right) is a TEM replica of another area at the arrow in 4489, showing evidence of glide-plane decohesion (at A's) as well as smooth areas of stretching (as at B). Some surface oxidation apparently occurred after fracture. See also 4492.

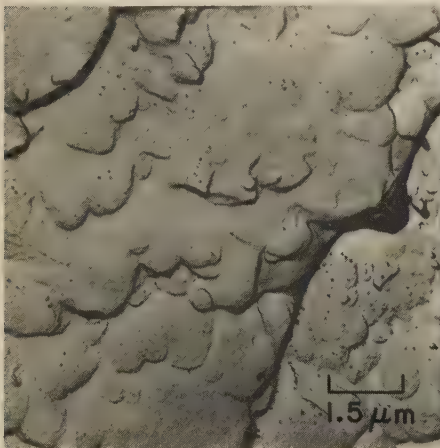
4492 TEM replica of a third area at the arrow in 4489. The elongated dimples here indicate local tearing during fracture, suggesting that multiple ligaments between intergranular separations ruptured by overload.

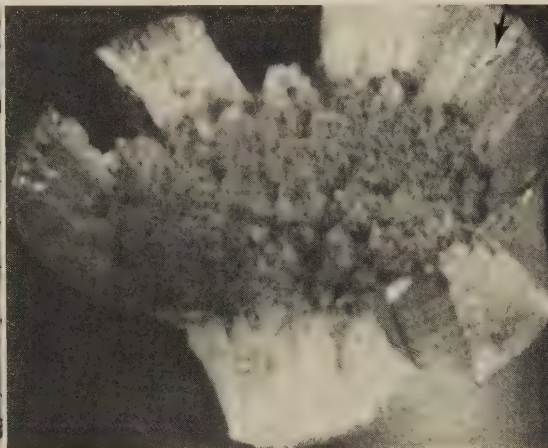
4493 A cup-and-cone fracture in an unnotched specimen of nickel-base alloy 718 that broke by tension overload. Tensile strength was 1450 MPa (210 ksi). The shear lip exhibits a small amount of checking (as at arrow); the central fibrous area is extremely coarse. See 4494 to 4496.

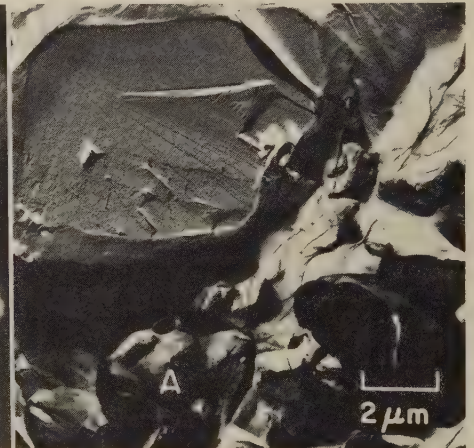
4494 TEM replica of an area in the central fibrous zone of the fracture surface in 4493. The major feature here is a large cleavage facet of a precipitate particle. Adjacent dimples (as at A) are essentially equiaxed.

4498 TEM replica of an area of the tension-overload fracture surface in fractograph 4497 (left), showing slightly elongated tear dimples but no sign of precipitate particles such as the one shown in fractograph 4494 (on the opposite page).

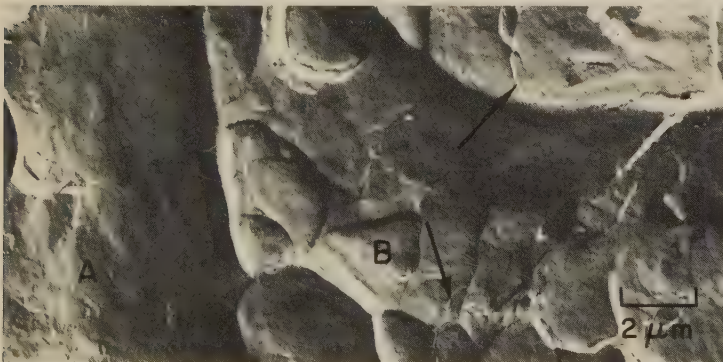
4495 TEM replica of a second area in the central fibrous zone in 4493. The dimples here, which appear to be essentially equiaxed, differ considerably in size (compare dimples at A and B). There appear to be some very minor secondary cracks (at arrows).

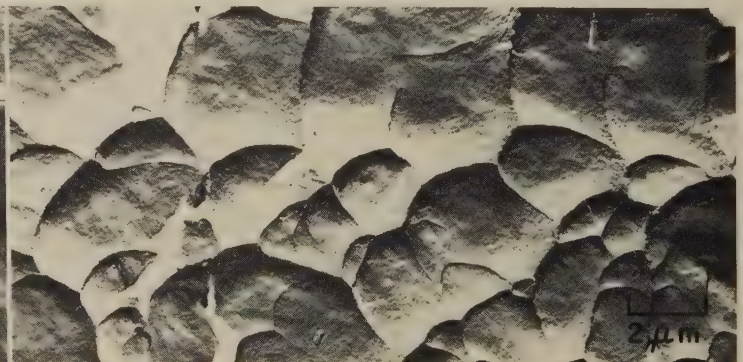
4496 TEM replica of a third area in the central fibrous zone in 4493. This area must be close to the shear lip, because the dimples here are somewhat directional. There are no signs of cleaved precipitate particles here or in 4495 (left).

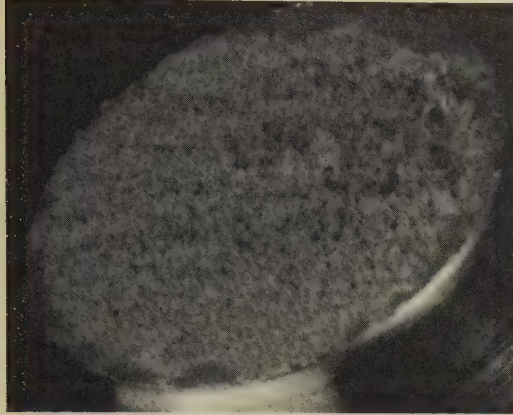
4497 Surface of a tension-overload fracture in a notched specimen of nickel-base alloy 718. Unnotched tensile strength, same as 4493; notched tensile strength, 2048 MPa (297 ksi); $K_t = 3.5$. Fracture surface shows several crack nuclei at the notch. See 4498 to 4500.

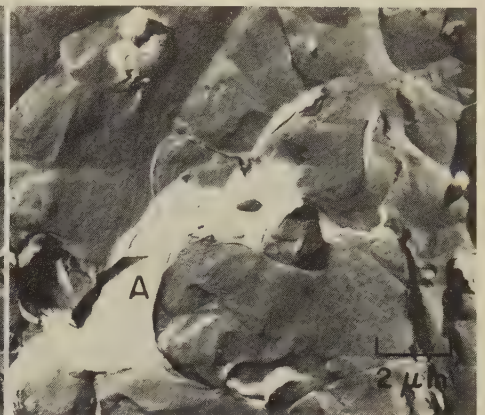
4499 TEM replica of another area of the fracture surface in 4497, showing tear dimples somewhat like those in 4498. White area at lower left (A) could be either a hole in the replica or an area that was shielded from heavy metal shadowing.

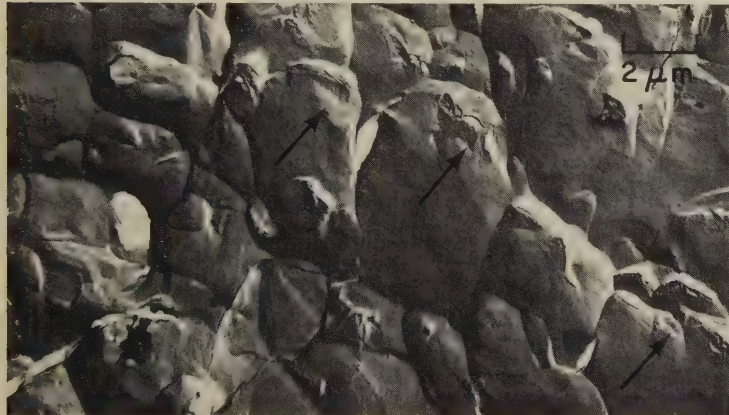
4500 TEM replica of a third area in 4497, showing both large and very small scattered dimples that are all slightly elongated. The bottoms of some of the dimples contain marks (as at arrows) suggesting that the first-stage plastic replica was marred during stripping.

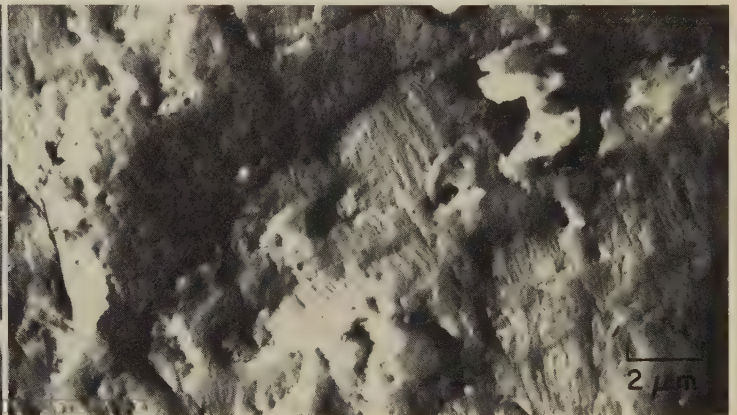
4501 TEM replica of an area in the fatigue zone in 4502 (below, left), near the areas shown in 4503 and 4504. Fatigue striations are clearly evident in some of the fracture facets, but the intervening facets have smooth contours with tiny pockmarks that may be inclusions.

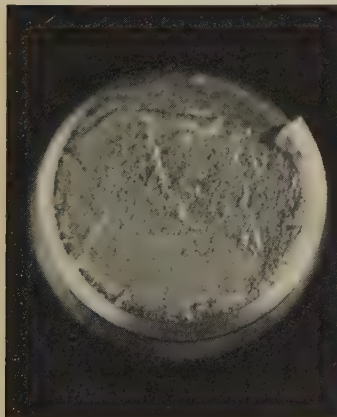
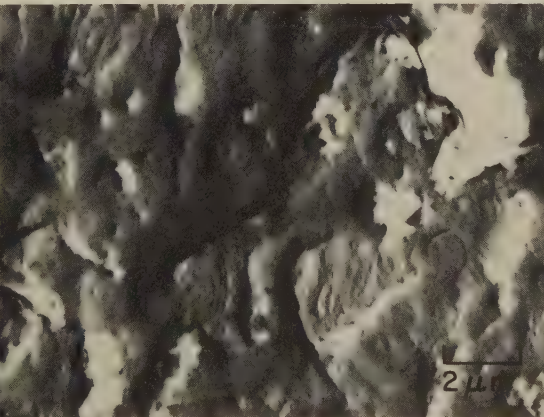
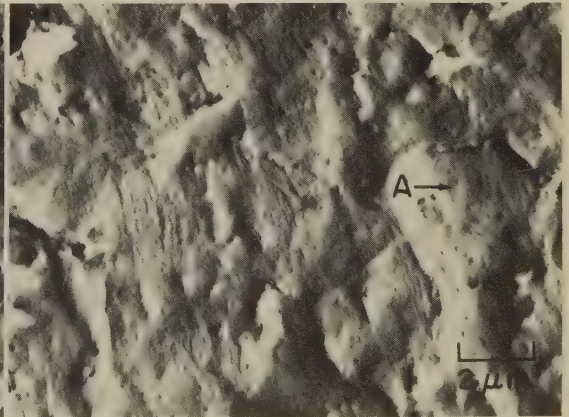
4502, 4503, 4504

Fractograph 4502 (left) shows the surface of a low-cycle fatigue fracture in a threaded bolt of nickel-base alloy 718 (same tensile strength as in 4493) that was loaded to a tensile stress of 862 MPa (125 ksi). Fracture occurred after 33,000 cycles. Many crack nuclei are visible in the thread root. Fractograph 4503 (center) is a TEM replica of an area in the fatigue zone at the bottom of the fracture surface in 4502 and shows isolated patches of fatigue striations that are rather indistinct and not uniformly spaced. Fractograph 4504 (right) is a TEM replica of another area in the fatigue zone in 4502 and shows fatigue striations more generally distributed than those in 4503 and present even on rounded features (as at A). See also 4501, above.

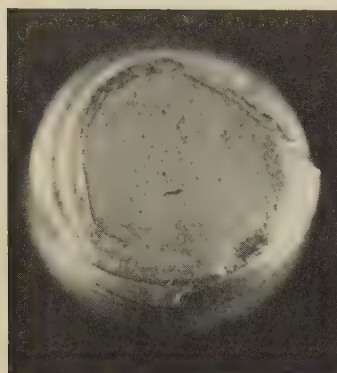
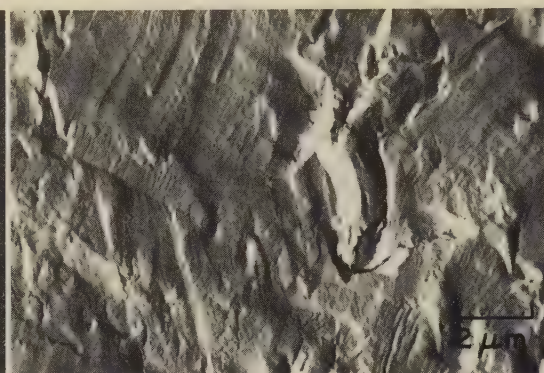
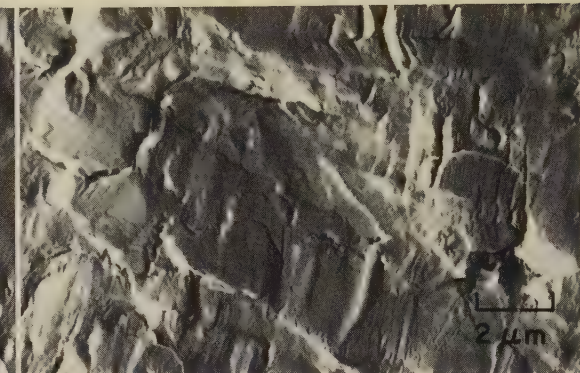
4505, 4506, 4507

Fractograph 4505 (left) shows the surface of a high-cycle fatigue fracture in a threaded bolt of nickel-base alloy 718 (tensile strength, 1450 MPa or 210 ksi) that was loaded in tension-tension ($R=0.1$) with a major stress of 414 MPa (60 ksi). Fracture occurred after 1,648,000 cycles. Fractograph 4506 (center) is a TEM replica of an area in the fatigue zone of the fracture surface in 4505, showing well-defined fatigue striations. Note that the striation patterns in certain grains at right show that these grains are oriented at 30° to the general array of grains. Fractograph 4507 (right) is a TEM replica of another area in the fatigue zone in 4505. This replica shows many smooth regions containing extremely faint fatigue striations. Note that at left there are features that resemble both intergranular and transgranular secondary cracks. See also fractograph 4508.

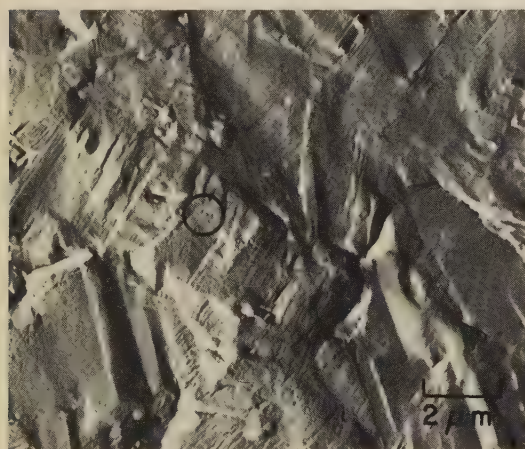
4508

TEM replica of a third area in the fatigue zone in 4505. Nearly all of the grains here show regular fatigue striations, some of which are oriented 45° to their neighbors. The three small dots in the circle near center may be "tire tracks".

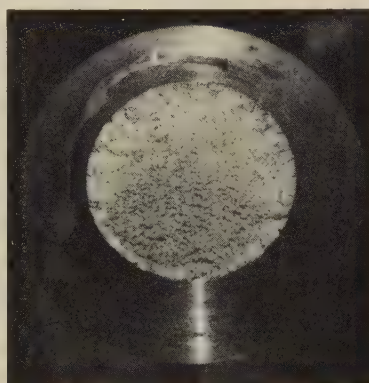
4509

High-cycle fatigue fracture in a notched specimen of alloy 718 solution treated, aged to tensile strength of 1393 MPa (202 ksi), loaded to tensile stress cycled from 138 to 689 MPa (20 to 100 ksi) at 500 cycles per minute, and broken after 11,800 cycles. See 4510 to 4513.

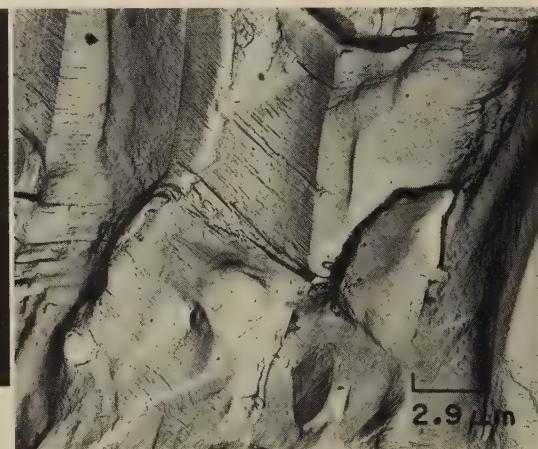
4510

TEM replica of an area at one of the fatigue-crack nuclei at the notch in 4509. Notch had 60° angle, 0.008-in. root radius, 0.30-in. diameter. Here, fatigue striations meet at sharp angles at twin boundaries. (The striations at bottom center are very faint.)
